DEPARTMENT OF TRANSPORTATION

Contract #: 04-0120F4Cty: SF/ALA Rte: 80 PM: 13.2/13.9File #: 69.28**WELDING INSPECTION REPORT****Resident Engineer:**Pursell, Gary**Address:** 333 Burma Road**City:** Oakland, CA 94607**Report No:** WIR-016460**Date Inspected:** 25-Aug-2010**Project Name:** SAS Superstructure**OSM Arrival Time:** 700**Prime Contractor:** American Bridge/Fluor Enterprises, a JV**OSM Departure Time:** 1900**Contractor:** Zhenhua Port Machinery Company, Ltd (ZPMC), Changxing Island **Location:** Shanghai, China**CWI Name:** Li Yang**CWI Present:** Yes No**Inspected CWI report:** Yes No N/A**Rod Oven in Use:** Yes No N/A**Electrode to specification:** Yes No N/A**Weld Procedures Followed:** Yes No N/A**Qualified Welders:** Yes No N/A**Verified Joint Fit-up:** Yes No N/A**Approved Drawings:** Yes No N/A**Approved WPS:** Yes No N/A**Delayed / Cancelled:** Yes No N/A**Bridge No:** 34-0006**Component:** OBG Segment**Summary of Items Observed:**

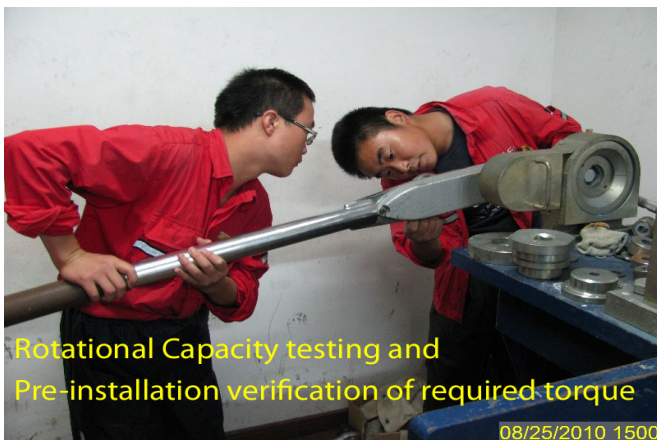
Unless otherwise noted, all work observed on this date appeared to generally comply with applicable contract documents.
